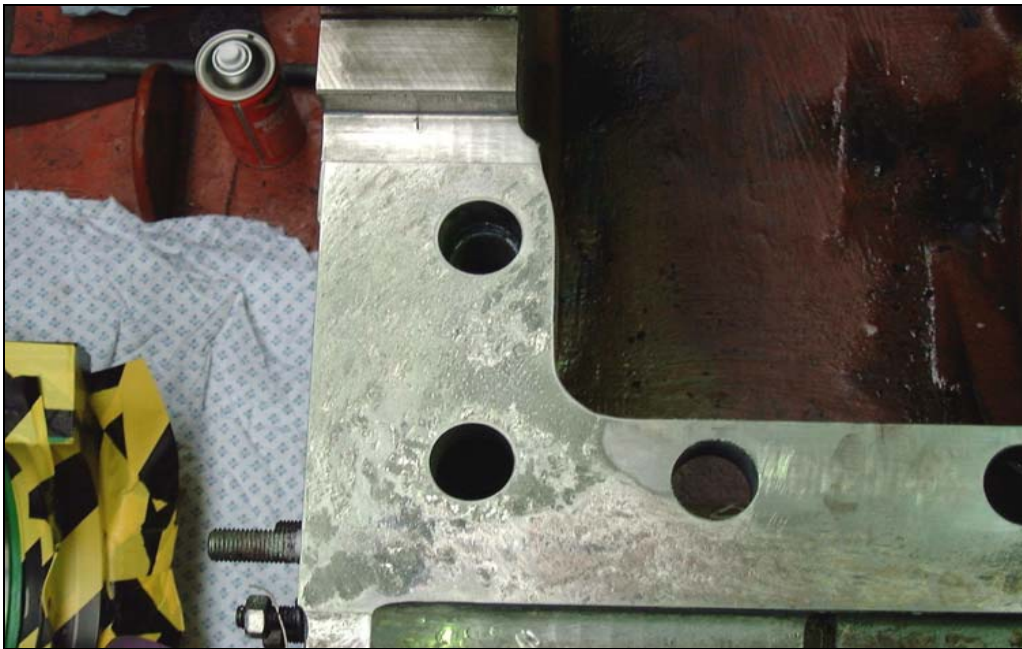
Badly Fretted Bedplate Mating Face
