A Case Study

Metal Stitching

Background To The Metal Stitching Repair

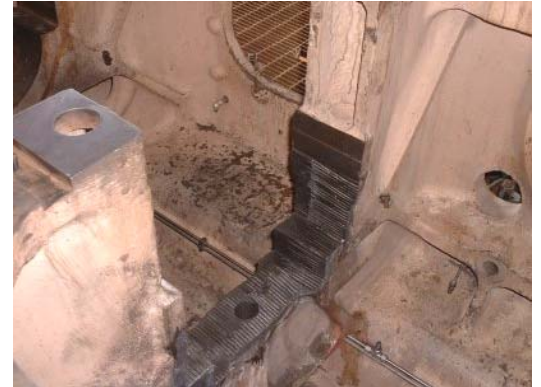
Main Bearing Pocket Section Removed

We drilled a series of holes around the damaged pocket conforming to the shape of the new insert. We removed the damaged portion, then carefully positioned, restrained and metal stitched the new insert carefully into place. (We manufactured the insert in our workshops in the UK).

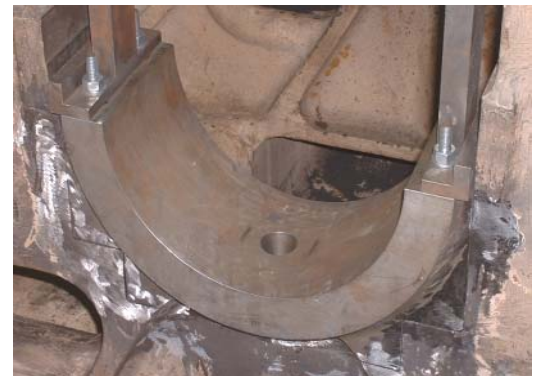
Inserting The New Pocket

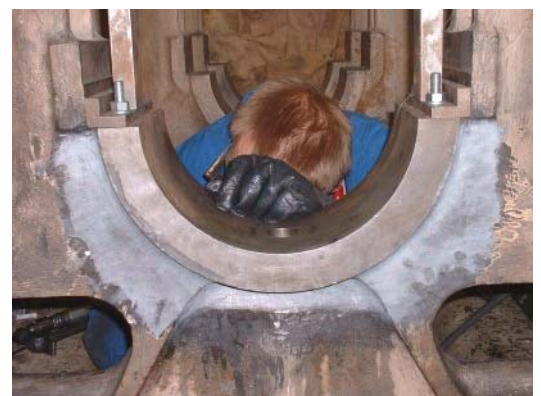
Finished Repair After Hand Dressing

After stitching we carefully hand ground and dressed the surrounding areas to blend in seamlessly with the original.
